MISCELLANEOUS PAPER S-72-5

# EVALUATION OF MO-MAT 158 AS LIGHT-DUTY LANDING MAT

February 1972

Conducted by **U. S. Army Engineer Waterways Experiment Station, Vicksburg, Mississippi**

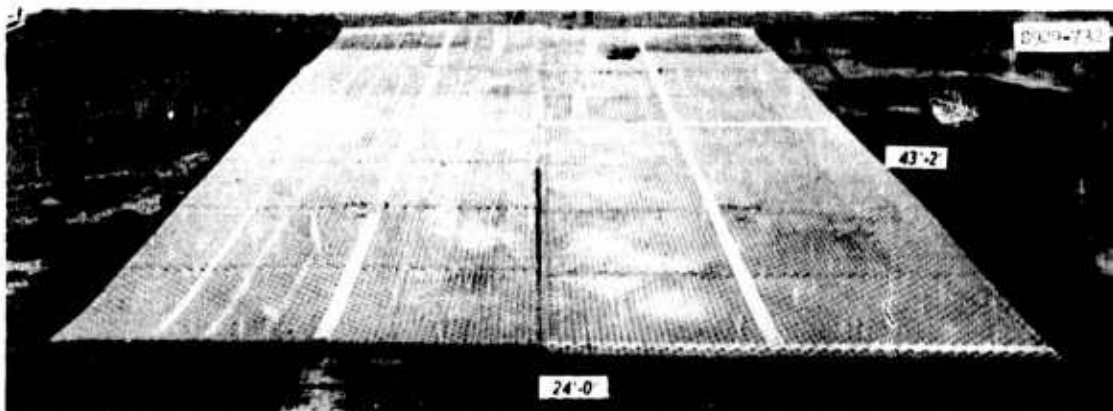
Fig. 1. Connected panels of MO-MAT 158

7. This investigation was conducted on four special panels of MO-MAT 158 connected by nut plates with bolts placed in predrilled holes spaced on 4-in. centers, which provided both longitudinal and transverse joints in the traffic lane. Each panel was composed of four 12-ft 2-in.-wide by 5-ft 8-1/4-in.-long sections bonded together along the long dimension with epoxy resin during fabrication. The effective size of each panel before joining was 21 ft 9 in. long by 12 ft 2 in. wide (plate 1a). The panels had an average material thickness of 0.183 in., and the overall thickness measured from the bottom of one node to the top of an adjacent node was approximately 3/4 in. Two panels were connected along the 12-ft 2-in. dimension to form the transverse joint, and the other two panels were also connected in a similar manner. The two 43-ft 2-in. long by 12-ft 2-in.-wide sections were then joined (fig. 1) with an

8-in. offset along the long dimension so that the factory bonded joints and transverse joints would not be aligned when the longitudinal joint was formed (plate 1b). When joined together, the four special panels covered an area 43 ft 2 in. long and 24 ft wide and weighed 2.00 lb per square foot of placing area.

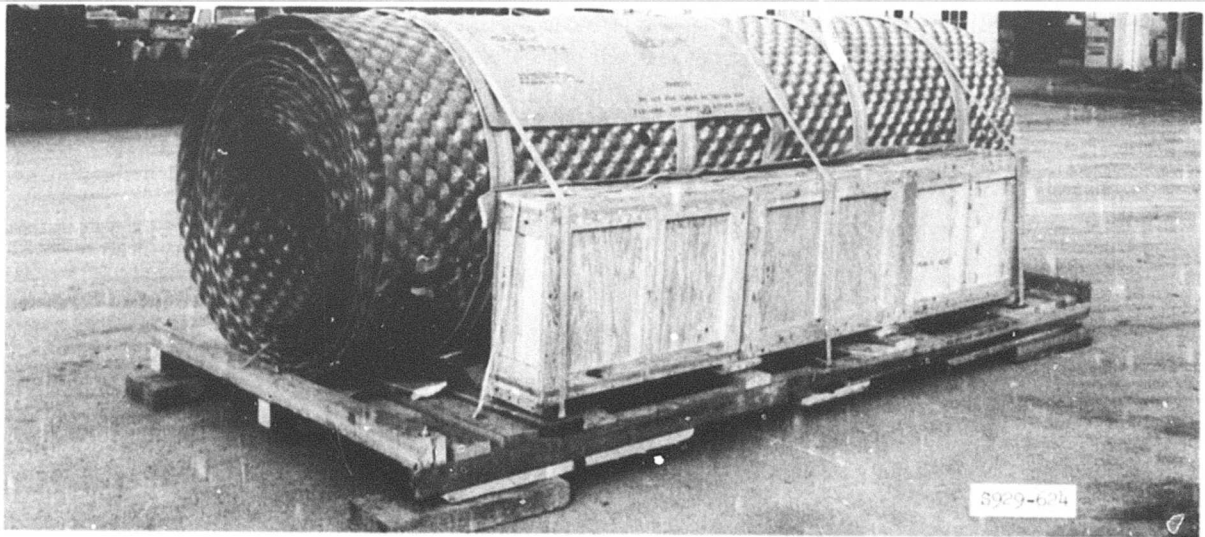
Fig 2. Bundle of MO-MAT and accessories

8. A bundle of rolled MO-MAT and accessories was secured to a wooden skid with metal bands and shipped to WES for testing (fig. 2). The bundle was 12 ft 6 in. long, 6 ft wide, and 5 ft 5 in. high. The

cubage of the bundle was 407 cu ft, and the total weight was 5095 lb. The roll had an inside diameter of 2 ft 6 in., and an outside diameter of 4 ft 11 in. Included in the bundle were the four panels of MO-MAT 158, MO-MAT 85 to be used as approach mat, and accessories, which included nut plates, bolts, sealant material, wrenches, and metal anchors.

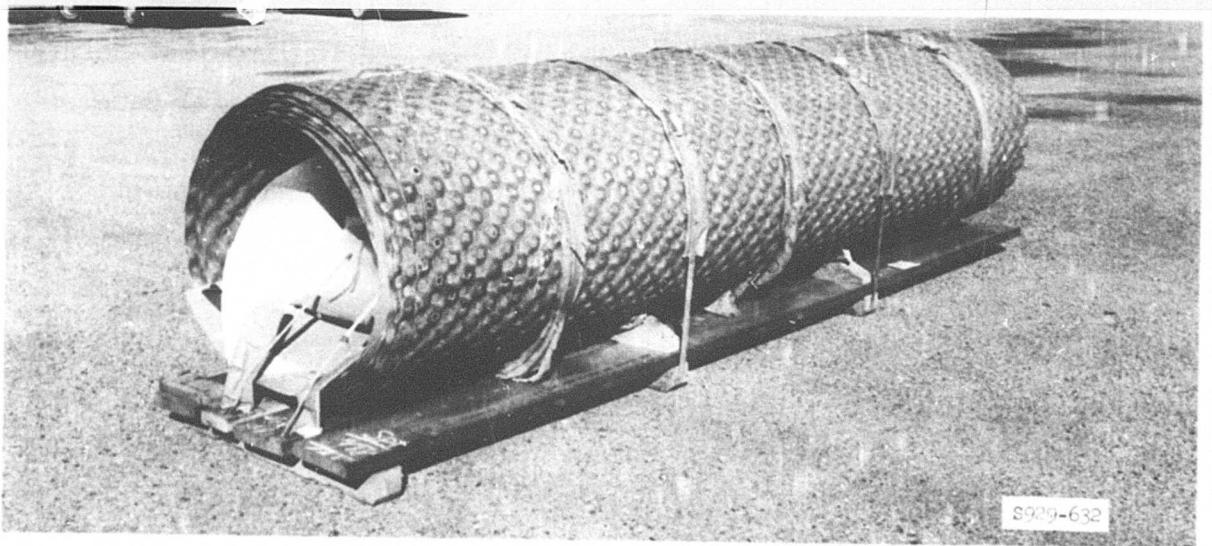
Fig. 3. Bundle of MO-MAT and water bag

9. Another bundle of MO-MAT with a rubber water bag inside the roll was also secured to a wooden skid with metal bands for shipment to WES (fig. 3). The roll had an inside diameter of 2 ft 11 in., and an outside diameter of 3 ft 8 in. The bundle was 12 ft 6 in. long, 3 ft 9 in. wide, and 4 ft 2 in. high, with a cubage of 195 cu ft. The total

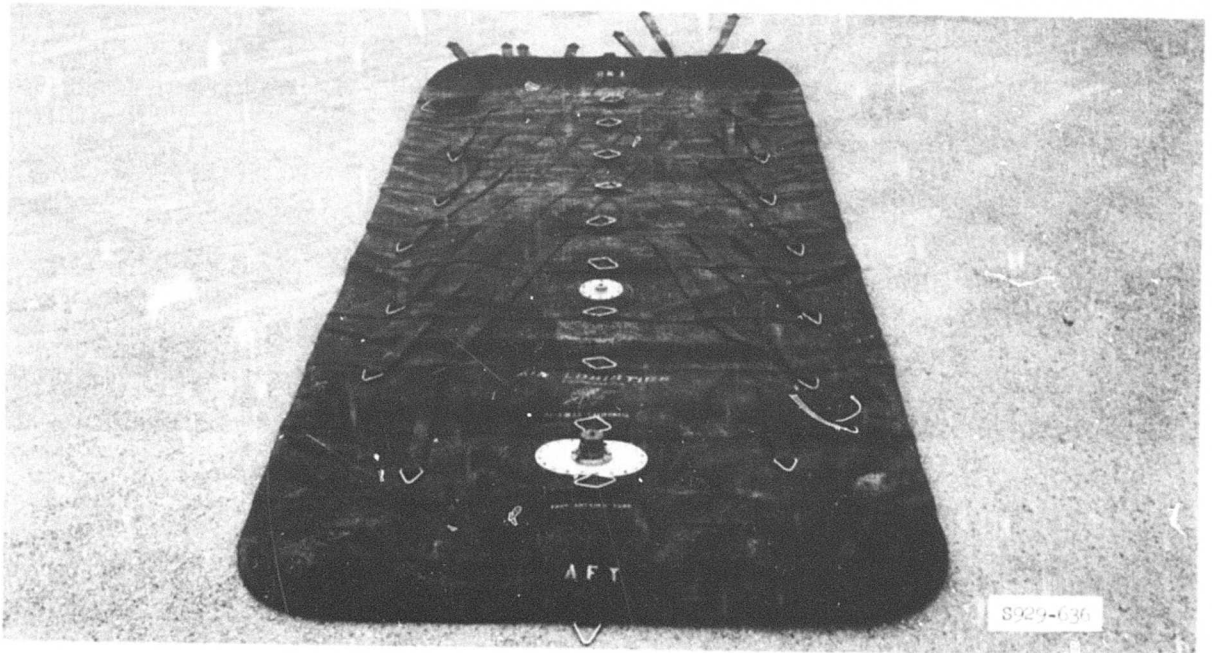
Fig. 4. Empty water bag

weight of the bundle was 1900 lb. Included in the bundle were MO-MAT 85 to be used as approach mat and a 3000-gal-capacity water bag, which weighed 625 lb empty (fig. 4). The water bag was recommended and furnished by the MO-MAT manufacturer to eliminate bow waves that had developed in previous MO-MAT tests due to the action of the rolling wheel.

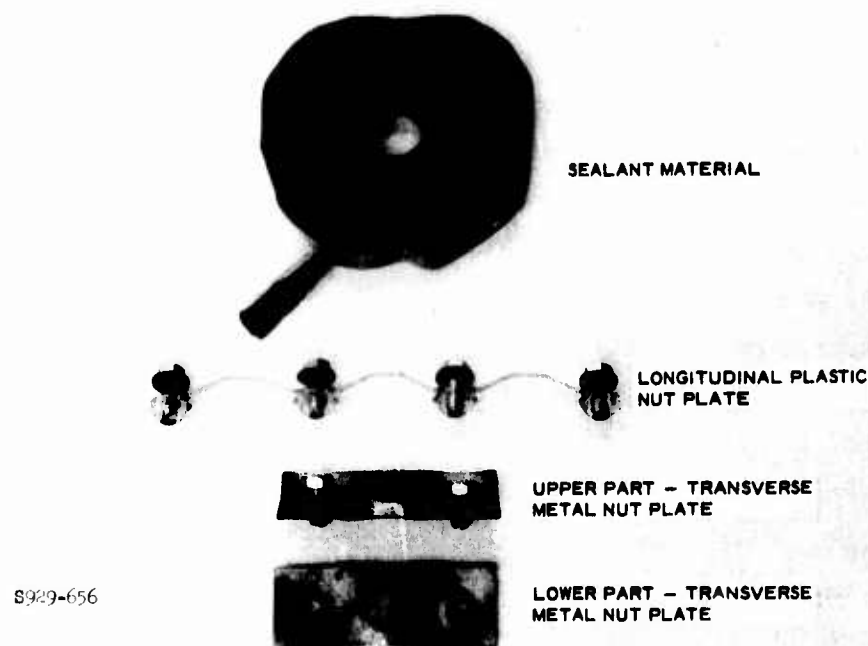
Fig. 5. Accessories for joining MO-MAT

12. All components for surfacing for the first test, including MO-MAT 85 and MO-MAT 158, were assembled at one end of the test section. Transverse joints (joints perpendicular to the direction of traffic) were formed by securing metal nut plates to the underlap panel, applying sealant stripping for waterproofing purposes, and overlapping the panels 4 in. Accessories for joining the MO-MAT are shown in fig. 5.

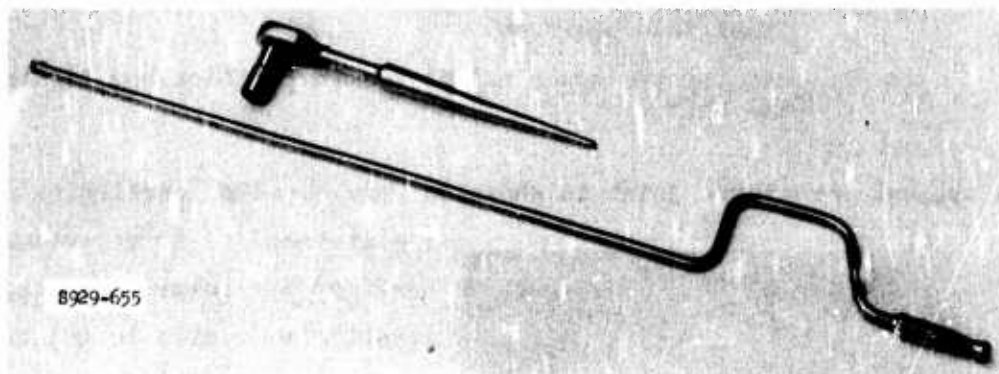
Fig. 6. Tools for assembling MO-MAT

The panels were secured by bolts located on 4-in. centers and tightened by a ratchet and speed handle (fig. 6). The lower part of the transverse metal nut plate (fig. 5) was designed to snap into position for retainment during assembly of the transverse joint; however, it was determined during assembly that these nut plates would not retain their positions. Therefore, transverse joints were assembled by:

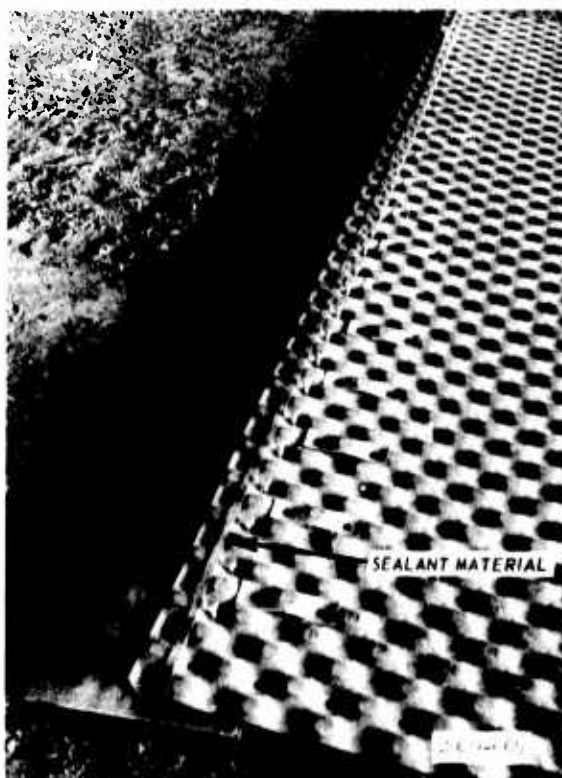
Fig. 7. Underlap panel prior to bolting

- a. Aligning the overlap and underlap holes with the tapered end of the ratchet.
- b. Holding the overlap panel up while the bottom nut plates were placed on a flat surface beneath the underlap and held in position by a few turns of the bolts (fig. 7).
- c. Placing the sealant strip. (Note sealant material in fig. 7.)

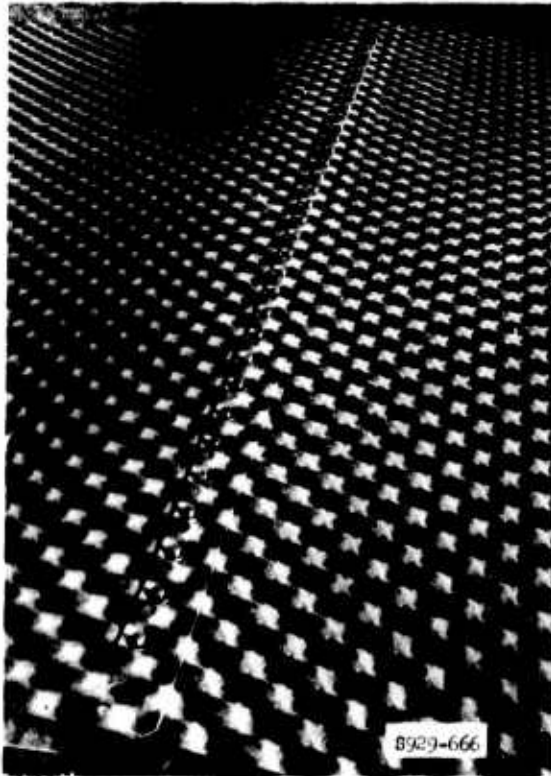
Fig. 8. Typical transverse joint after bolting

A typical transverse joint is shown in fig. 8. The longitudinal joint

(joint parallel to direction of traffic) was formed by securing plastic nut plates to the underlap panel, applying sealant stripping for waterproofing purposes, and overlapping the panels 4 in. The plastic longitudinal nut plates (fig. 5) snapped into the underlap panels and remained in position during installation without any difficulty. The four special panels, shown connected in fig. 1, were assembled by an experienced crew of eight men at an average rate of 150 sq ft per man-hour.

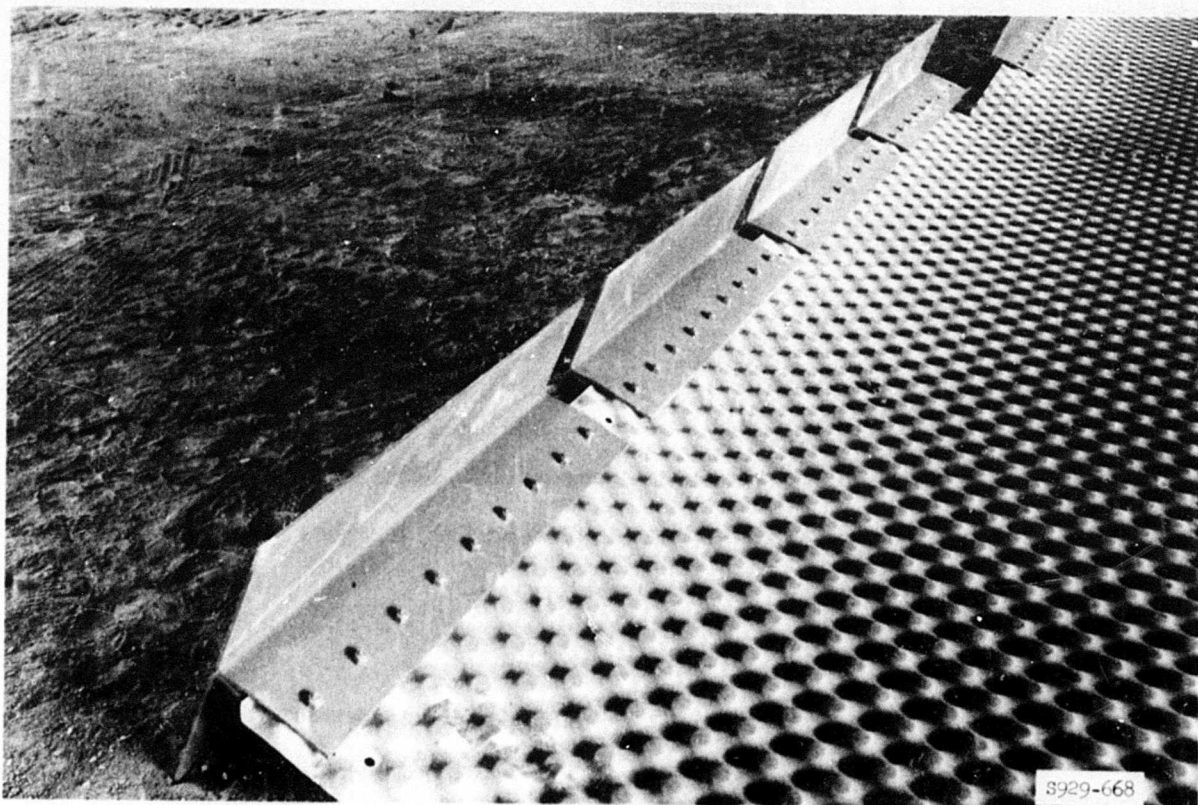
Fig. 9. Metal anchors connected to MO-MAT 85

13. After all mat had been assembled at one end of the test section, metal anchors were connected to the opposite end of the MO-MAT 85 (fig. 9), a cable was at-

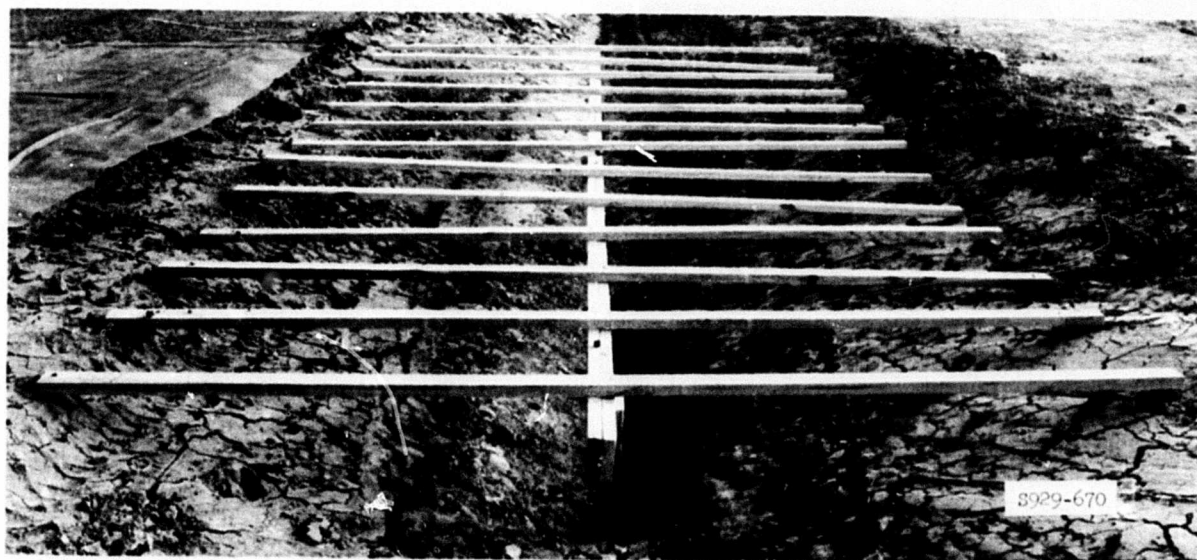
Fig. 10. View of catenary ditch and support frame

tached to the anchors, and the mat-attached anchors were pulled by a truck-powered winch across the test section and the catenary ditch (fig. 10). A support frame was built in the catenary ditch to prevent the MO-MAT from sagging during installation. The mat-attached anchors were placed in the north anchor ditch, and then the ditch was backfilled (fig. 11). Prior to anchorage on the south end, the support frame across the catenary ditch was lifted with jacks to remove all possible mat sag across the ditch (fig. 12). After the south anchor ditch had been backfilled the support frame was removed. Then the water bag was

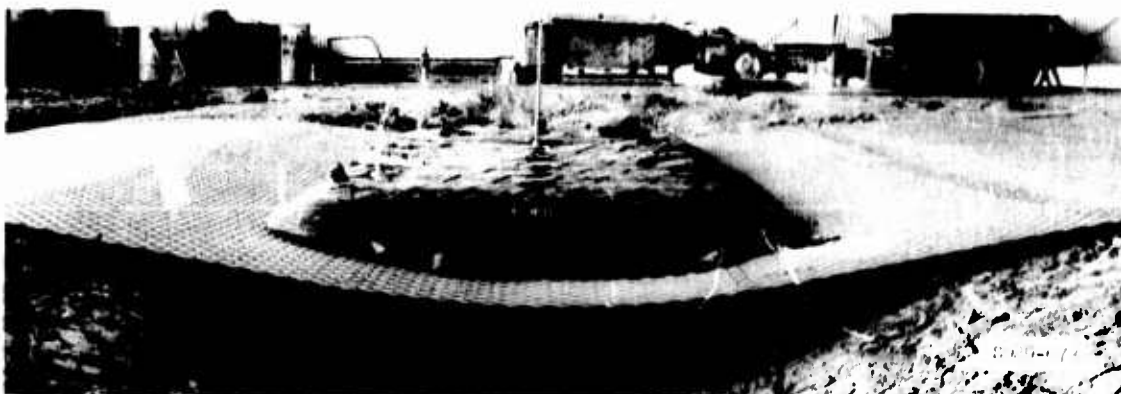
Fig. 13. Water bag on mat over catenary ditch

was positioned on the MO-MAT and was filled with 1100 gal of water to provide posttensioning to the MO-MAT to eliminate bow waves caused by a moving wheel (fig. 13). A view of the overall test section ready for traffic tests is shown in photo 1.

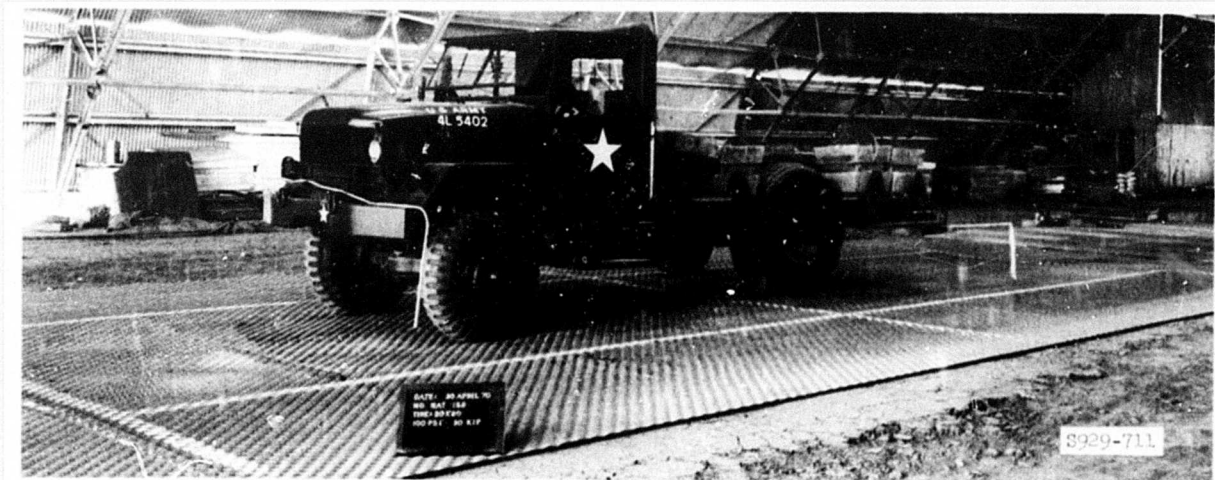
Fig. 14. C-130 load cart with 30,000-lb single-wheel load on 20.00-20 tire inflated to 100 psi

14. A specially designed single-wheel test cart (fig. 14) loaded to 30,000 lb was used in the traffic tests. It was fitted with an

outrigger wheel (load considered insignificant) to prevent overturning and was powered by the front half of a four-wheel-drive truck. The load wheel had a 20.00-20, 22-ply tire inflated to 100 psi, which produced a contact area of 291 sq in. and an average contact pressure of 103 psi.

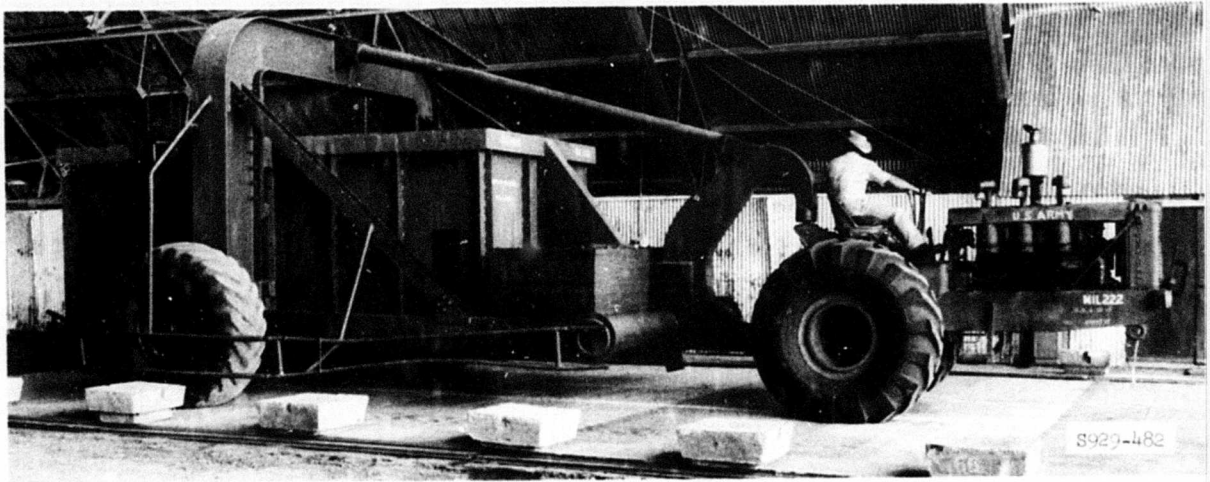
Fig. 15. C-130 load cart with 30,000-lb single-wheel load on 20.00-20 tire inflated to 100 psi

21. Water was applied to the surface of the mat and to edges of the section in order to prevent drying of the subgrade, and all longitudinal joint bolts were tightened prior to continuance of traffic. Traffic was continued in order that the MO-MAT could be further evaluated but had to be temporarily terminated after 184 coverages because the severe rutting in item 1 tended to tip the small load cart to an unbalanced condition. Therefore, another load cart (C-130 load cart with 30,000-lb single-wheel load on 20.00-20 tire inflated to 100 psi) was used for further traffic (fig. 15).

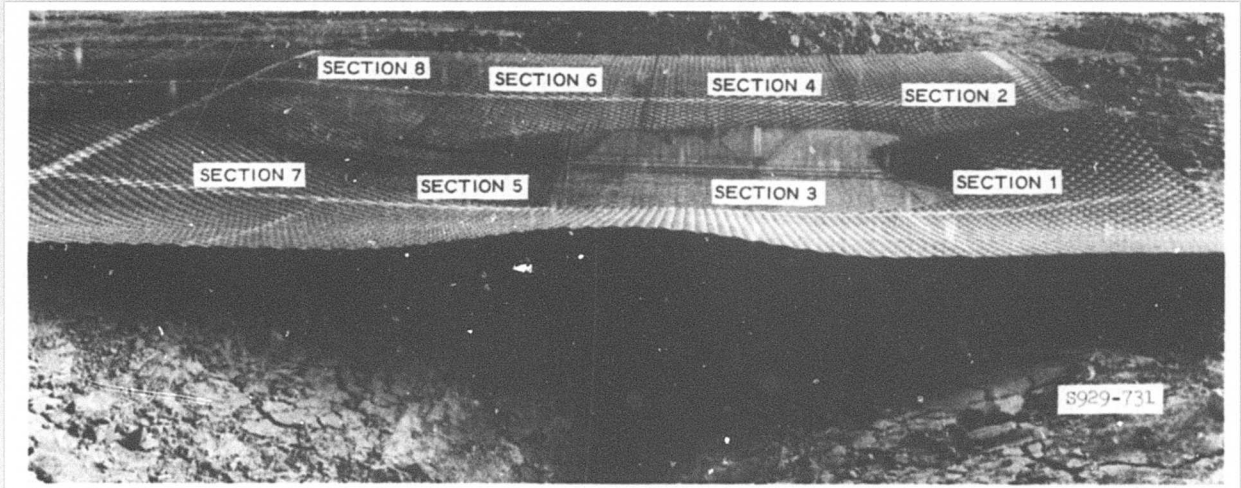
Fig. 16. Waterproofing capability test setup

30. After the traffic tests, MO-MAT 158 was disconnected from MO-MAT 85 at both the north and south approaches, and tests were conducted to determine the waterproofing capability of the repaired longitudinal joint described in paragraph 27. The MO-MAT 158 that was initially placed between sta 0+00 and 0+15 was moved and positioned between two spanning pipes across the catenary ditch in order that water could be ponded on

the mat (fig. 16). After water had been applied to the top surface of the MO-MAT, leakage was observed at the longitudinal joint, at the cracked factory bonded joint, and at the center of a section where material had delaminated. Leakage locations are shown in plate 4.

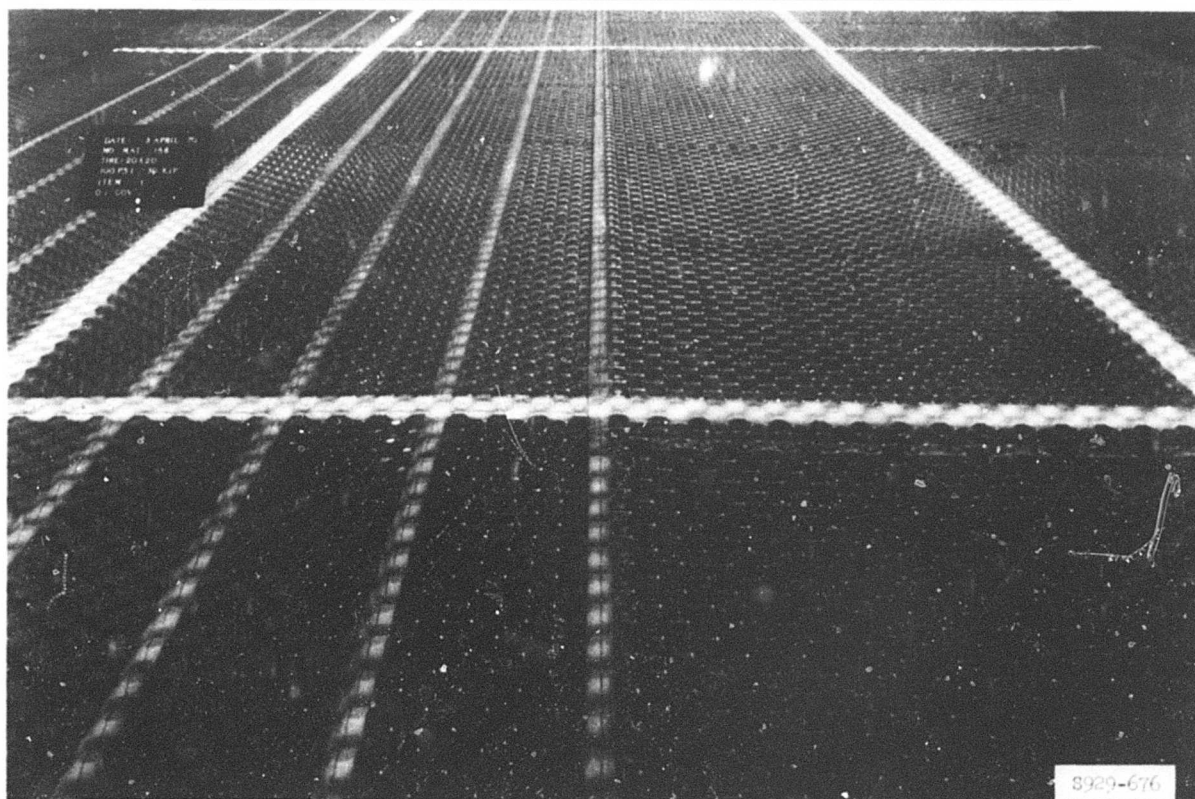
20. Traffic tests. The average CBR of item 1 at the start of traffic was 4.1 (table 1), and the mat surface was generally smooth (photo 2). After 96 coverages of traffic, item 1 was considered failed due to excessive longitudinal rutting along the traffic lane (photo 3). The criterion for failure was the development of 3 in. of deformation measured laterally across the traffic lane over a 10-ft distance.<sup>6</sup> When a deformation of 3 in. or more occurred, a test item or section was considered failed due to roughness. Photo 4 shows a 3-7/8-in. deformation measured with a 10-ft straightedge across sections 1 and 2 of item 1. Deformation measurements, summarized in table 3, show a maximum of 3-7/8 in. after 96 coverages. The maximum change in static deflections beneath the tire from the beginning to 96 coverages of traffic was 0.3 in., which occurred at the quarter-point joint of sections 5 and 7 (plate 6). The maximum changes in both cross-section (plate 8) and profile (plate 10) measurements from the beginning to 96 coverages of traffic were 1.1 and 1.7 in., respectively.

Photo 2. Item 1 prior to traffic, test 1

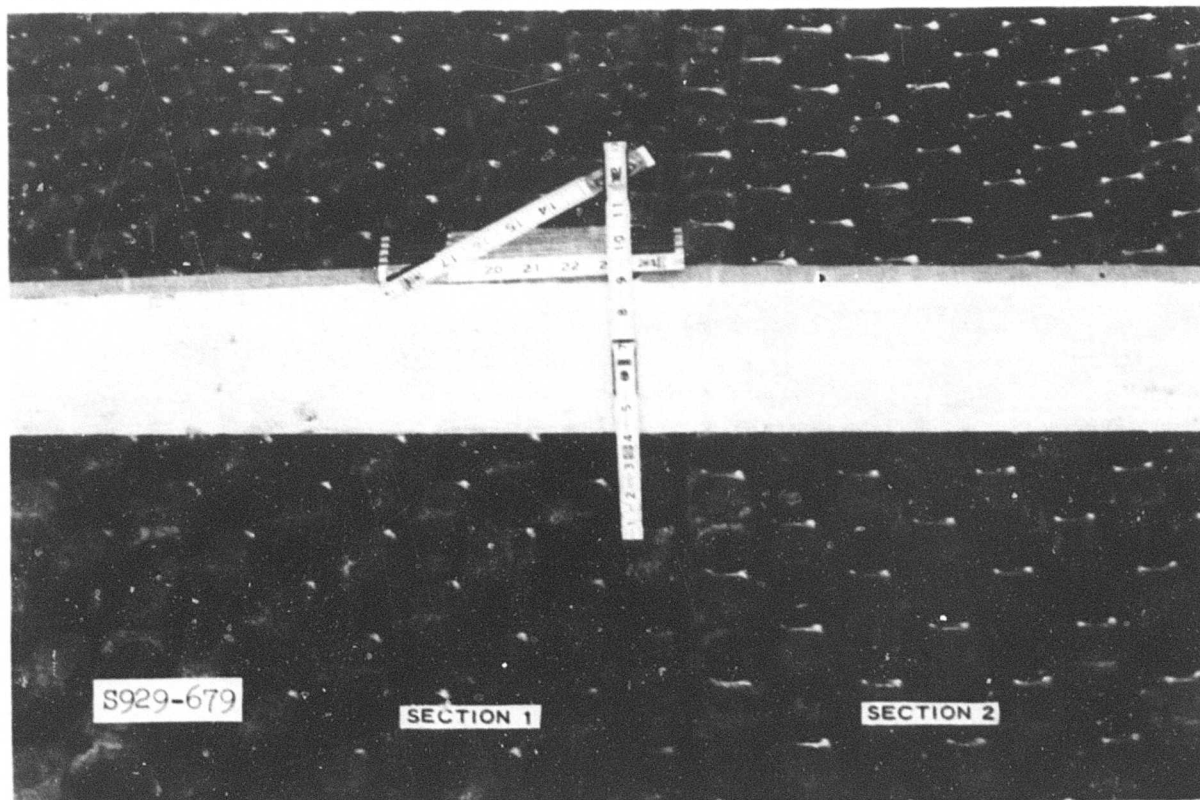
Photo 4. Close-up of 3-7/8-in. deformation across sections 1 and 2 of item 1 after 96 coverages, test 1

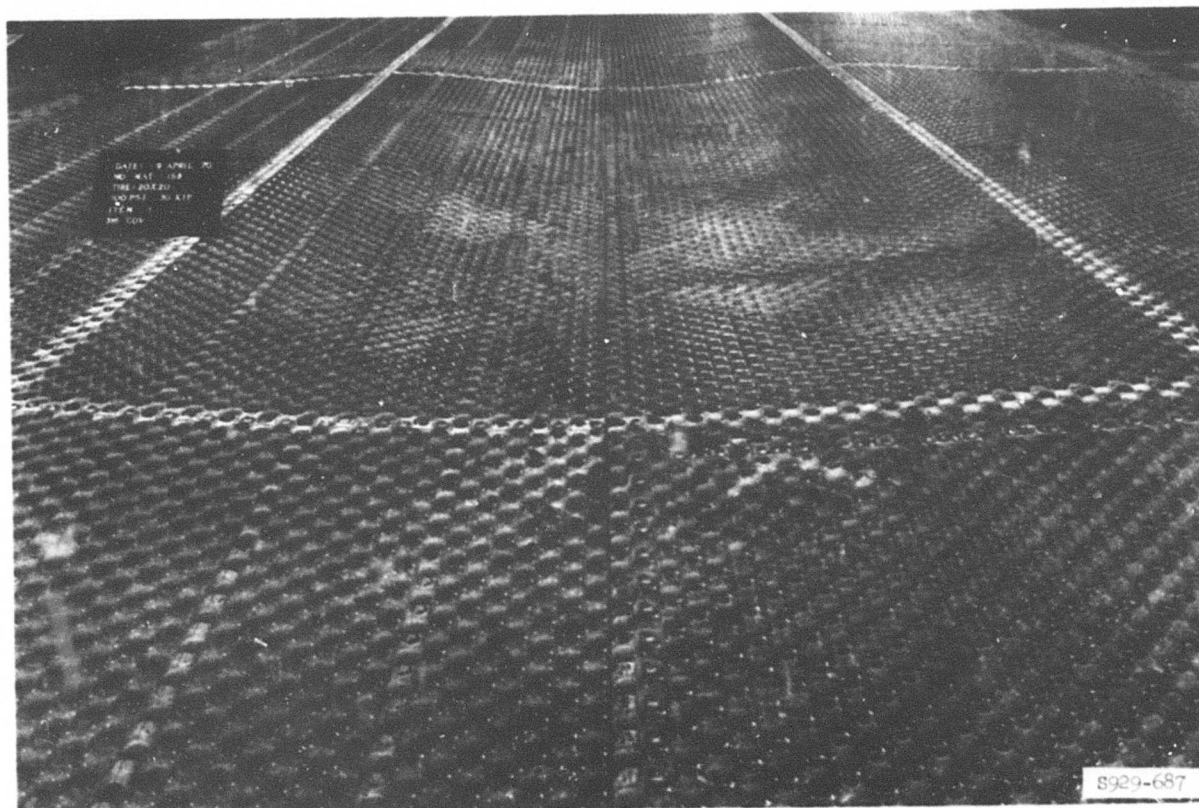
22. Traffic was resumed using the larger load cart; however, after 316 coverages, traffic was terminated (photo 5). Deformation across sections 3 and 4 had progressed to 6-1/2 in. (photo 6), and with the load wheel positioned at the same location, the deformation

Photo 5. Item 1 after 316 coverages, test 1

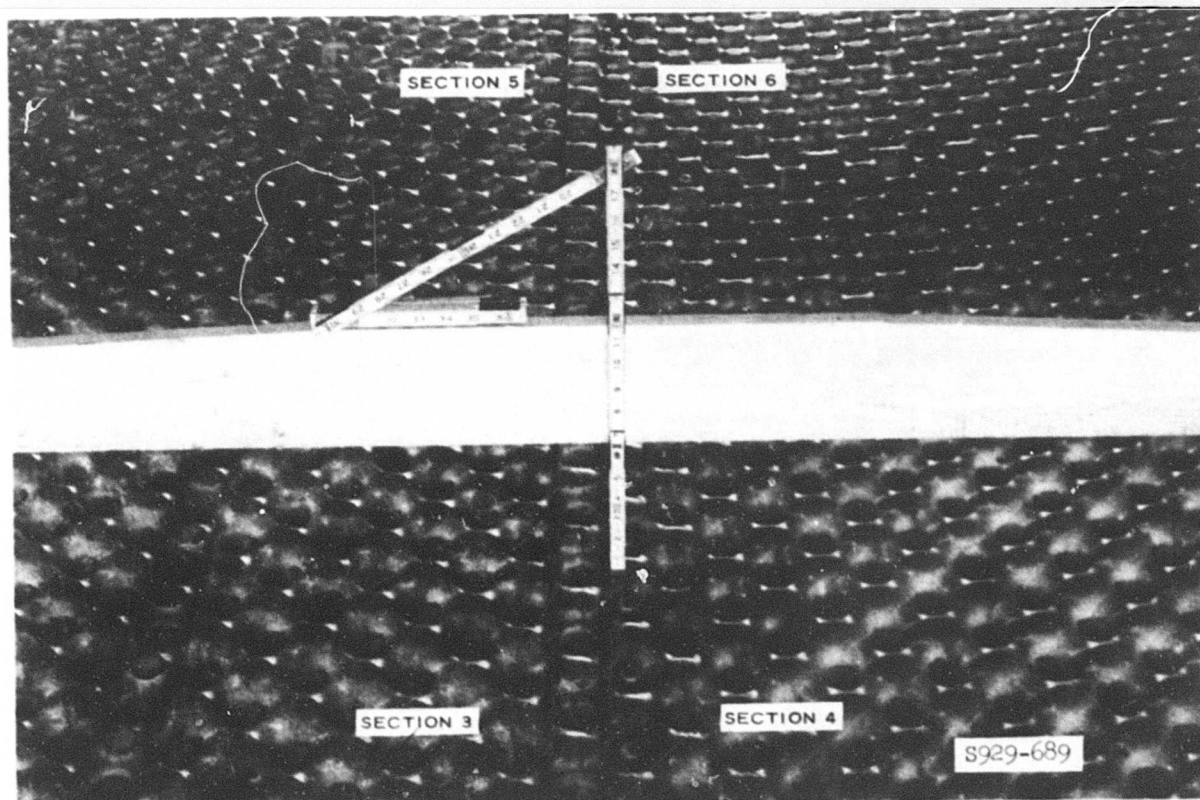
Photo 6. Deformation of 6-1/2 in. across sections 3 and 4 after 316 coverages, test 1.

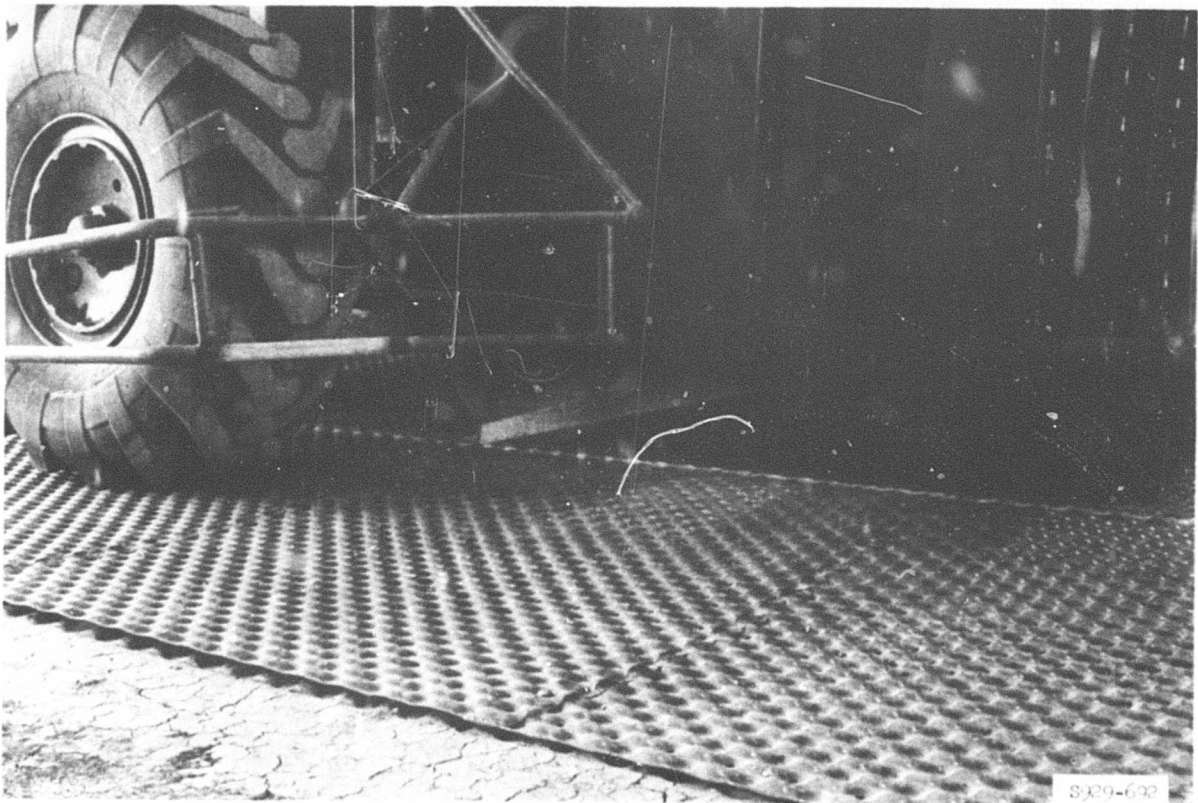
increased to 8-1/16 in. (photo 7). No mat breakage had occurred after 316 coverages.

Photo 7. Load wheel deforming mat and subgrade 8-1/16 in. across sections 3 and 4 after 316 coverages, test 1

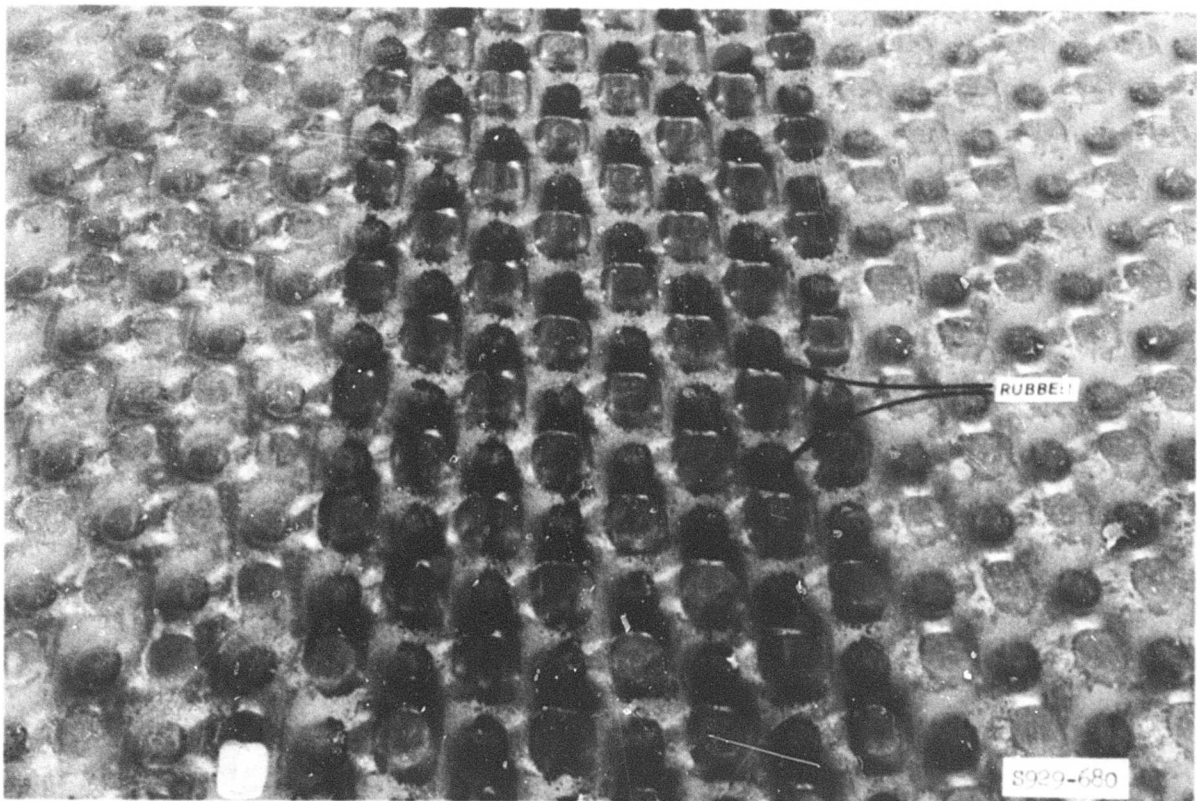
increased by application of antiskid particles to the mat surface during fabrication. Tire wear on the wet surface was negligible, but small pieces of rubber were peeled from the tire during skids on the dry surface (photo 8).

Photo 8. Evidence of tire wear on dry surface

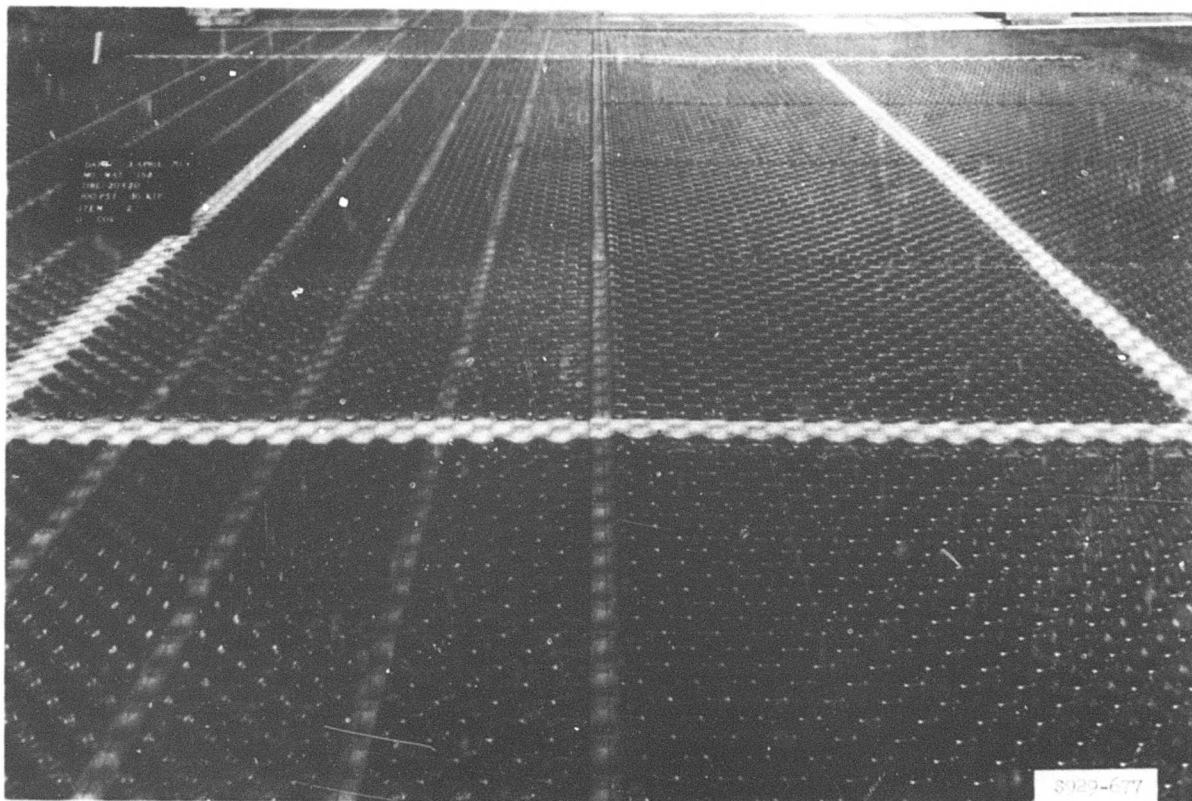
24. The average CBR of the subgrade for item 2 at the start of traffic was 6.6 (table 1), and the mat surface was relatively smooth (photo 9). After 184 coverages, item 2 was considered failed due to 3-in. deformations across the traffic lane (photo 10). Because the water bag placed tension on the mat, the mat surface did not conform to the actual subgrade deformation across the traffic lane. Therefore, the load wheel was positioned on the bridging mat in order that true subgrade deformation could be measured with a 10-ft straightedge. Deformation measurements are summarized in table 3. The maximum change in static deflections beneath the tire from the beginning to 184 coverages of traffic was 0.3 in., which occurred at the quarter-point joint of sections 10 and 12 (plate 6). The maximum change in both cross-section (plate 8) and profile (plate 10) measurements from the beginning to 184 coverages of traffic was 1.7 in. Although the section was considered failed when the 3-in. deformation was reached, traffic was continued to 316 coverages in order that the mat could be further evaluated (photo 11). Bolts along the longitudinal joint were not loosened by the action caused by the rolling wheel load, and no mat breakage had occurred after 316 coverages.

Photo 9. Item 2 prior to traffic, test 1

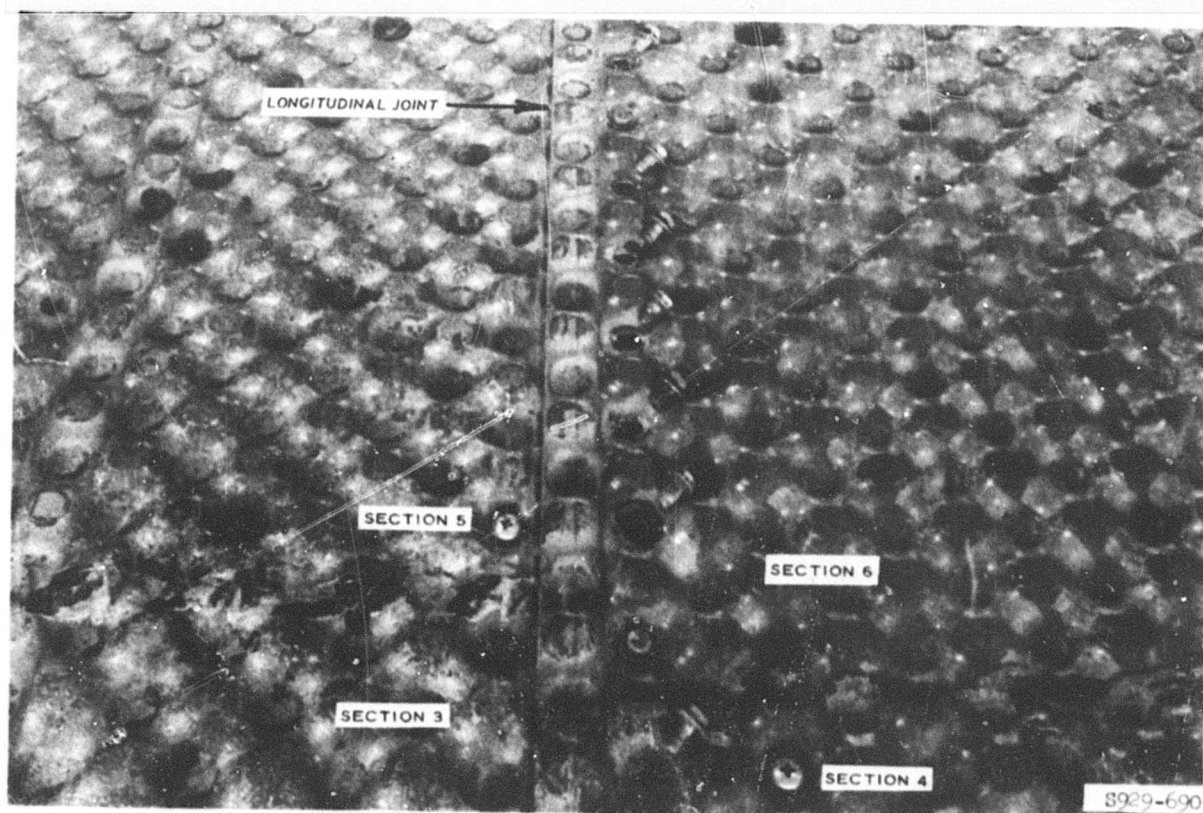
mat at sta 0+00 (plate 3). Inspection of several longitudinal nut plates removed from item 1 revealed that random threads were battered and stripped and portions of the plastic nut plates, which snap into the predrilled panel holes, were marred or broken off (photo 14). Photo 15 shows a close-up of threads stripped on a plastic nut plate that was typical of the type of damage incurred. The surface of the subgrade was moist; therefore, water that had been applied as described in paragraph 21 had seeped through the longitudinal and transverse joints. Subgrade deformations measured with a 10-ft straightedge on items 1 and 2 were 9 and 7-1/4 in., respectively (photos 16 and 17). The rated CBR's for items 1 and 2 were 4.0 and 6.5, respectively (table 1). Cross-section measurements of the mat and subgrade after traffic are presented in plate 11.

Photo 12. Close-up of bolts stripped from longitudinal joint between sections 5 and 6, test 1

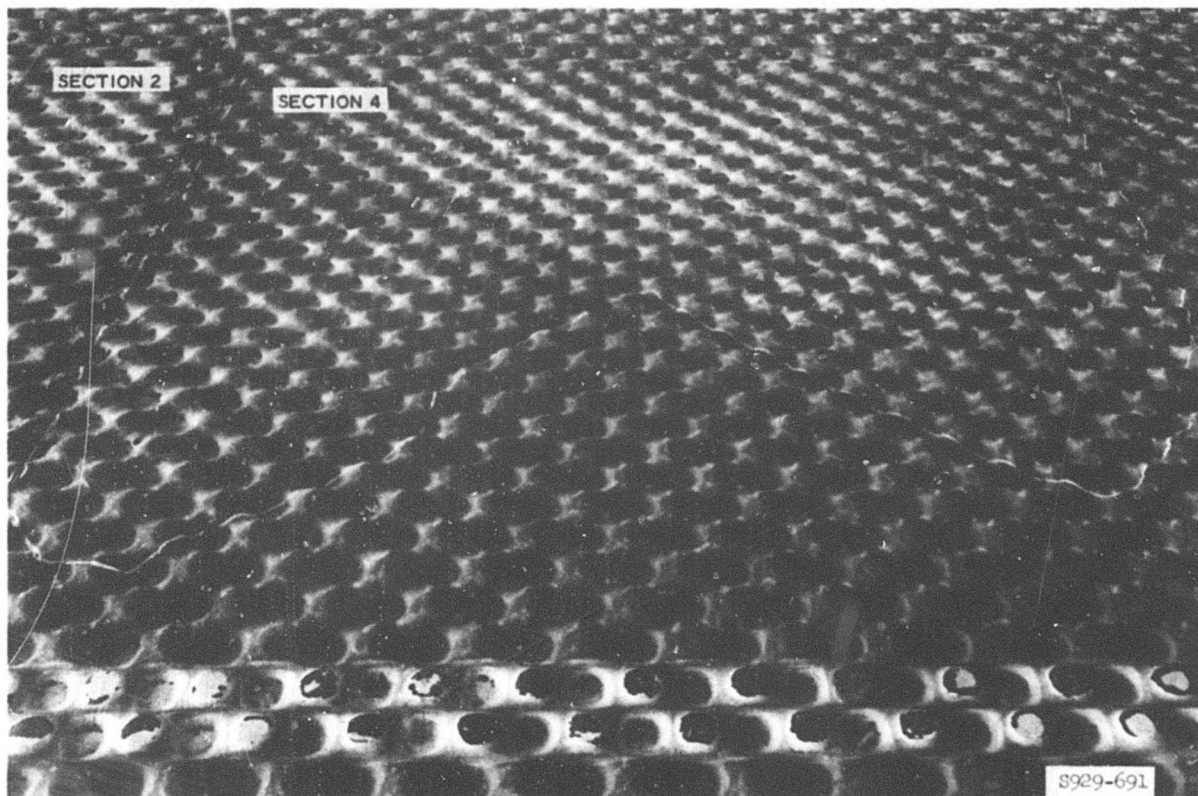
Photo 13. Typical delamination spot, test 1

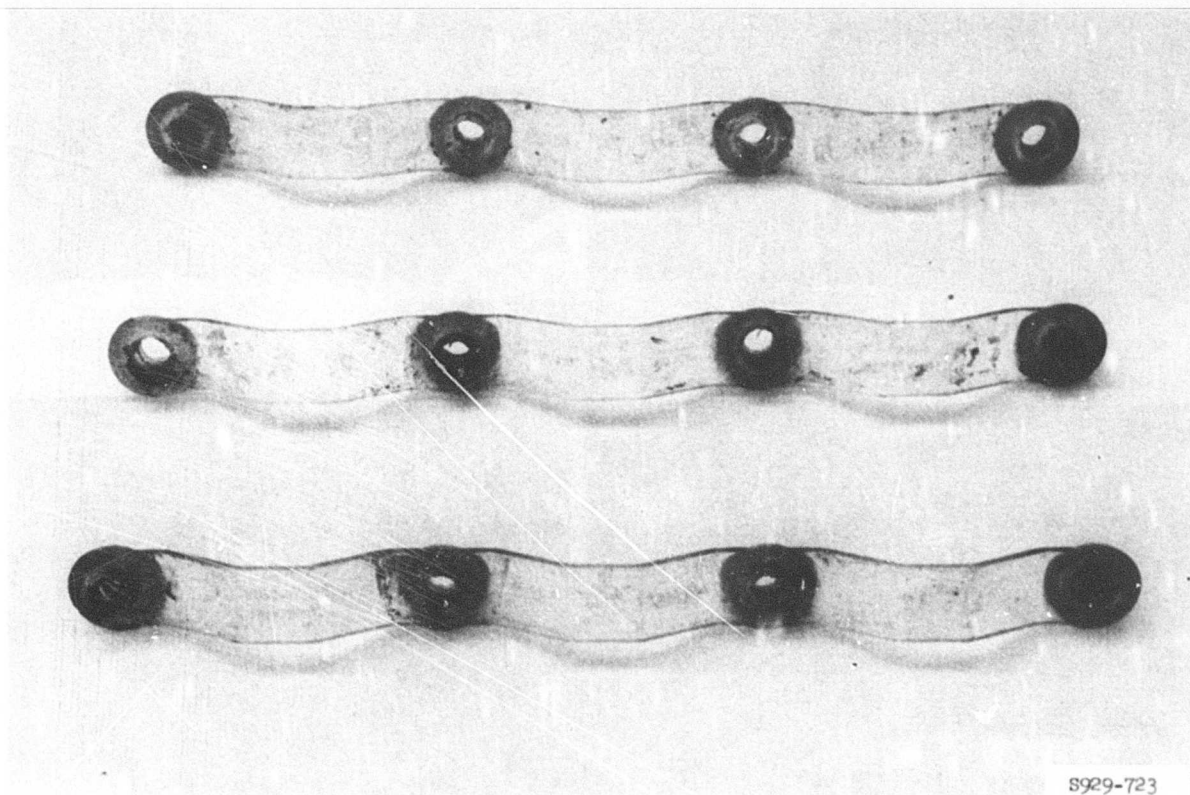
Photo 14. Typical damaged plastic nut plates, test 1

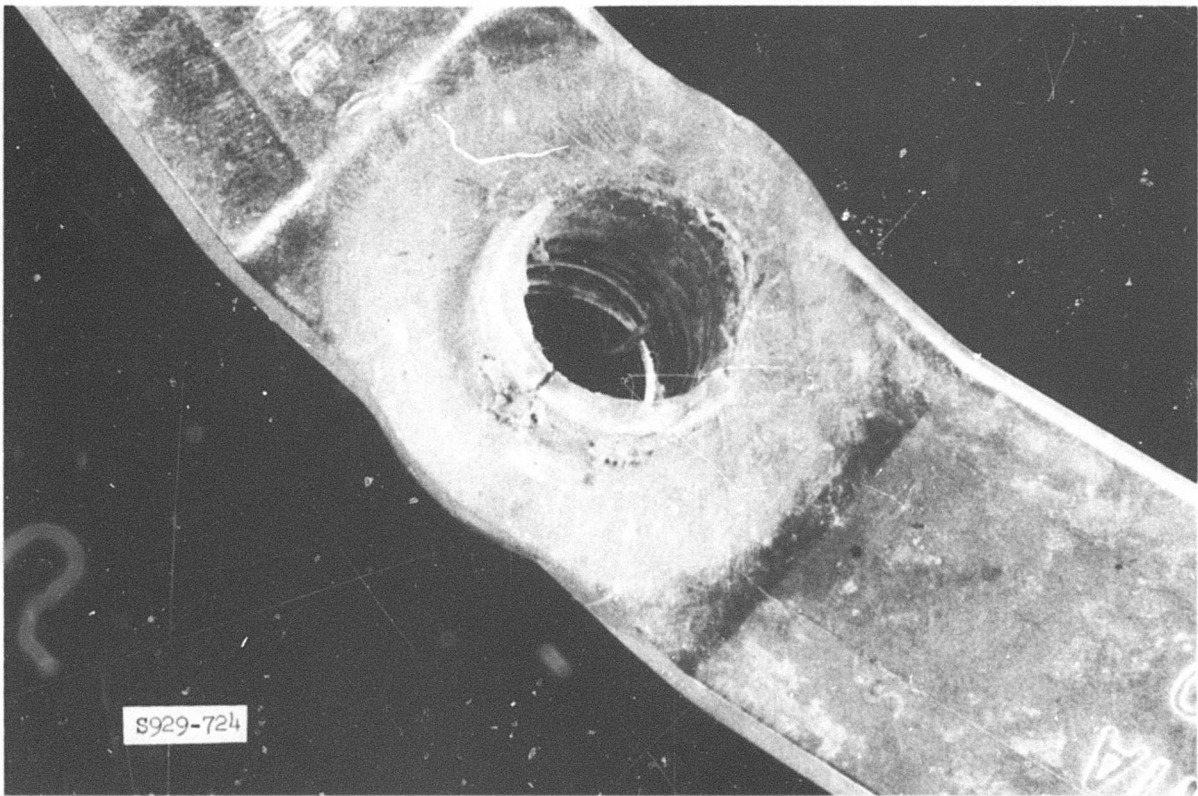
Photo 15. Close-up of stripped threads on plastic nut plate, test 1
